*****URGENT DEAR HEALTHCARE PROFESSIONAL COMMUNICATION*****

28 June 2021

To: Surgeons, Hospitals, Health care professionals
Description: Exactech Connexion GXL acetabular polyethylene liners

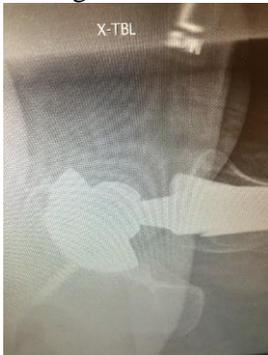
1. Significant combined anteversion with anterior edge loading of the femoral head on the acetabular liner

It is also noted that the index THA in many of the patients in these series was performed through a direct anterior approach. It has been reported that the direct anterior approach to the hip can lead to supranormal combined anteversion of the acetabular and femoral components with subsequent anterior edge loading[16], [18], [19].

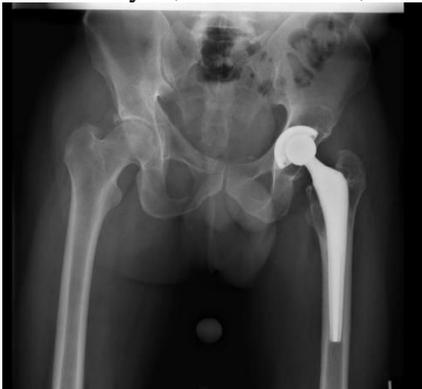
2. Osteolysis, radiolucencies, and/or asymmetric wear

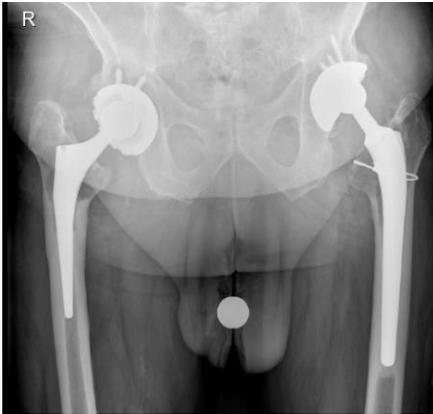
3. Significant vertical/abduction positioning of the acetabular component

9. When the combined anteversion and/or combined abduction of the acetabular and femoral components is high, edge loading and accelerated wear can present
